**Docket #(s):** W-01380A-09-0106

### FINANCING APPLICATION

RAY WATER COMPANY  
UTILITY NAME

IN THE MATTER OF THE APPLICATION	)	DOCKET NO. W-01380A
Of RAY WATER COMPANY, AN ARIZONA	)	
CORPORATION, FOR APPROVAL OF	)	FINANCING APPLICATION
LONG TERM FINANCING FOR REPLACEMENT	)	
OF AN EXISTING WELL.	)

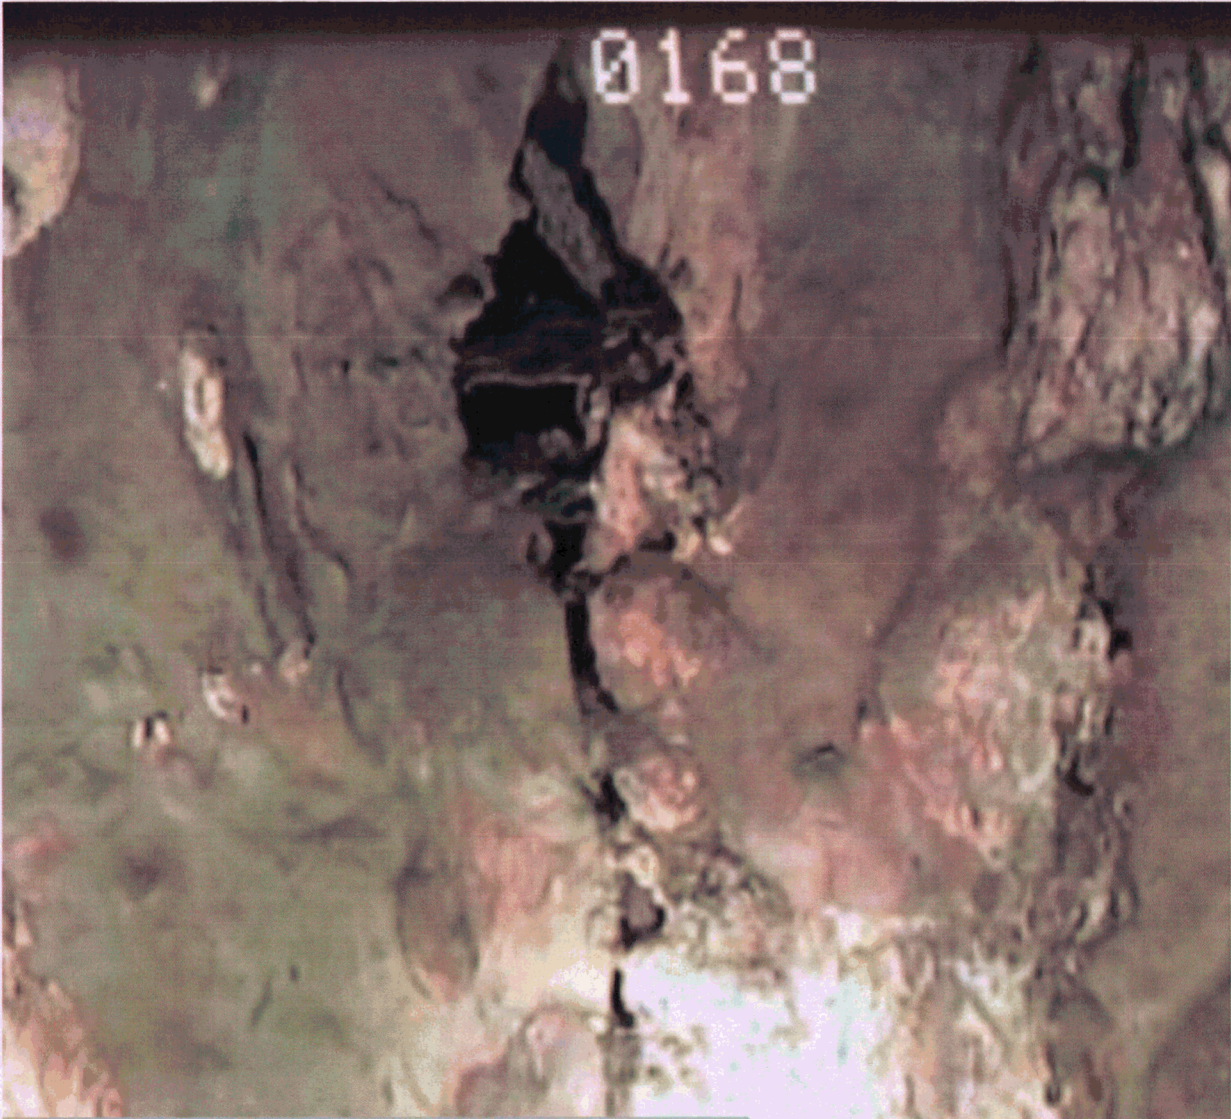
In February 2005, when replacing the pump and motor for this well, a video was performed, which indicated vertical splits in the well casing at several depth intervals. The casing splits included 166 to 168 feet; 174 to 177 feet; 186 to 206 feet; and 232 to 250 feet. Associated with the vertical casing splits are multiple corrosion holes, and the overall condition and structural integrity of the well is extremely poor. A photograph (screen capture from well video) of this well is presented in Attachment A. This well has been out of service since January 2005. Due to its age (52 years old) and the history of other wells in the Ray Water Company service area, Well No. 1 is considered to have come to the end of its economically useful life.

*Side view of Well No. 1 at 166 feet\* below land surface, showing vertical split and hole in well casing.*

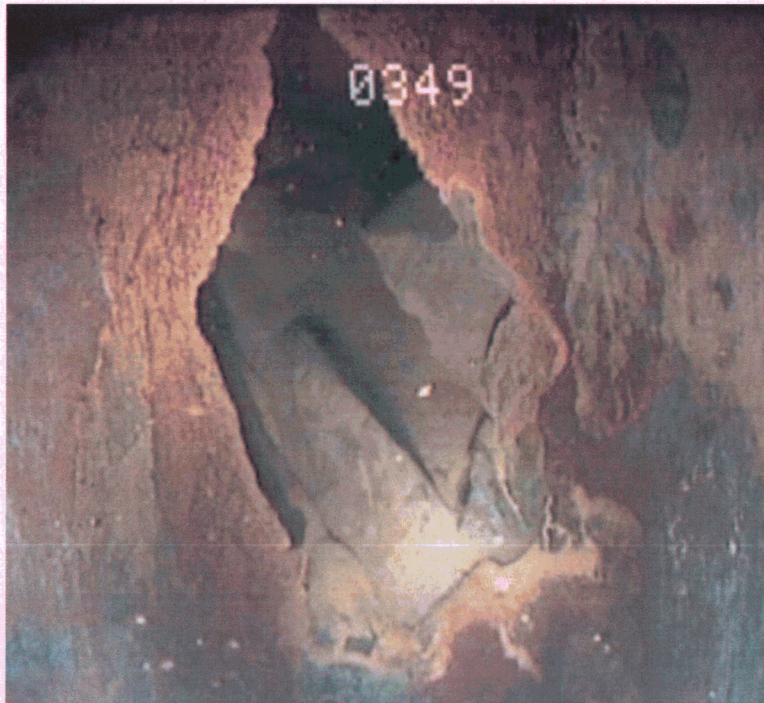
3  
4 A. Ray Water Company Well No. 3 is located at 5710 S. Herpa in Tucson, Arizona, and  
5 has ADWR Registration Number 55-609464. Well No. 3 was drilled by a cable tool  
6 rig in 1969. It has a 12-inch diameter machine perforated casing, a total depth of 458  
7 feet, and a static water level of 198 feet below land surface in June 2008. Well No. 3  
8 reportedly produces approximately 250 gpm. In 2008, a well video showed that the  
9 perforations were significantly blocked, so the well was cleaned by brushing and  
10 bailing. After the well was cleaned, the condition of the well casing (which was  
11 previously obscured by the accumulated scale) could be observed. A large corrosion  
12 hole in the wall of the steel casing was observed at a depth of approximately 347 feet.  
13 A photograph (screen capture from the well video) of the corrosion hole from at 347  
14 feet in this well is presented in Attachment A. A casing patch was subsequently

*Side view of Well No. 3 at 347 feet\* below land surface, showing a corrosion hole in the well casing.*

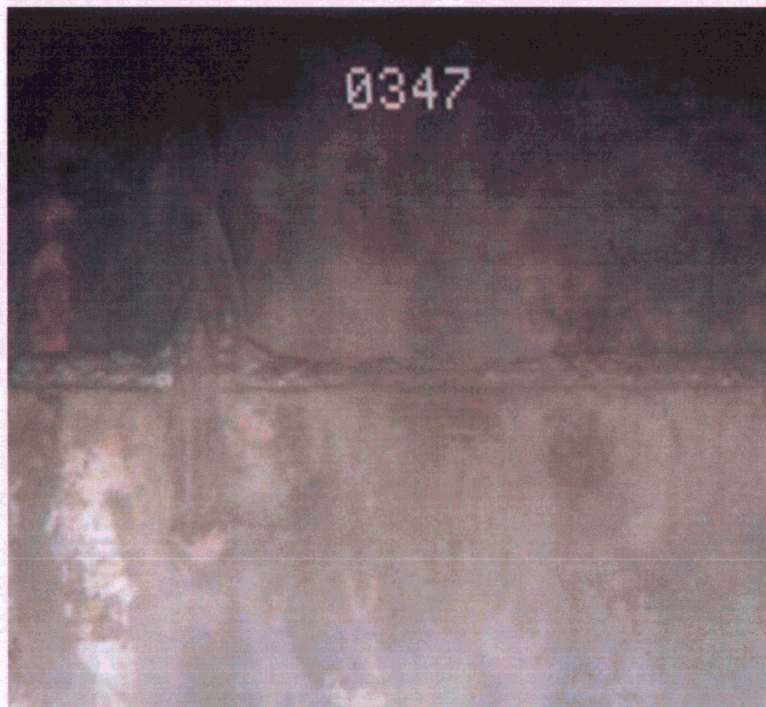
15 placed over the corrosion hole. The 4-foot long casing patch extends from 345 feet to  
16 349 feet, and a photograph of the top edge of the patched casing is also shown in  
17 Attachment A. Due to its age (40 years old) and the history of other wells in the Ray  
18 Water Company service area, Well No. 3 is considered to be near the end of its  
19 economically useful life.

*Side view of Well No. 3 at 345 feet\* below land surface, showing the top edge (see arrow) of the casing patch that was installed from 345 to 349 feet.*

1 A. Corrosion holes in steel well casings are rarely a localized condition, and typically  
2 reflect the overall corrosive characteristics of the aquifer material surrounding the  
3 well. This situation is indicated by many of the wells in the Ray Water Company  
4 system, which have corrosion holes at many locations within each well. Casing  
5 patches can be used to cover isolated problem areas, but as the corrosion becomes  
6 more extensive in older wells, the application of additional casing patches will not  
7 serve as effective "band-aids" to cover multiple problem areas, and will not provide  
8 structural stability of the overall well.  
9

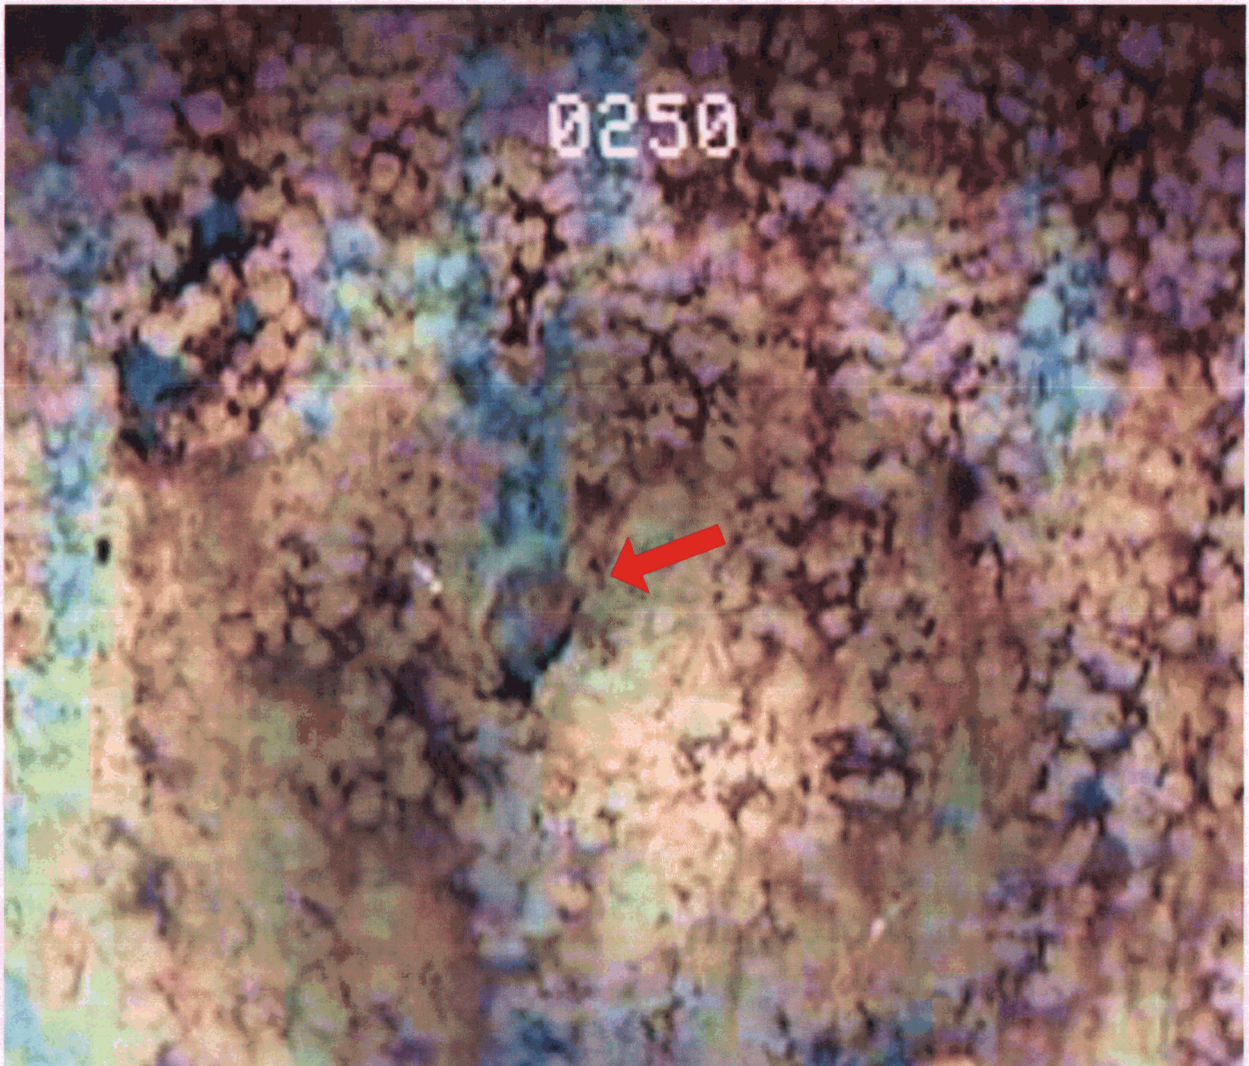
*Side view of Well No. 4 at 248 feet\* below land surface, showing a small corrosion hole (see arrow) in the well casing.*

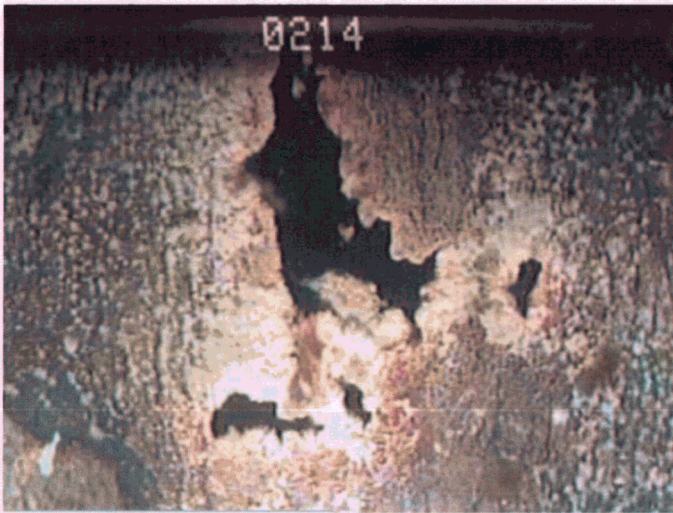
4 A. Ray Water Company Well No. 5 is located at 6100 S. Columbus in Tucson, Arizona,  
5 and has ADWR Registration Number 55-609466. Well No. 5 was drilled using the  
6 cable tool technique in 1963. It reportedly has a 12-inch diameter steel casing and a  
7 total depth of 331 feet. The static water level of this well was 194 feet in January  
8 2005. The well produced approximately 200 gpm for many years, but the well was  
9 taken out of service in 2004, after a well video revealed a significantly damaged  
10 casing with over 30 significant holes in the well casing. Photographs (screen captures  
11 from the well video) of the holes in the casing at various depths are presented in  
12 Attachment A. As seen in Attachment A, at a depth of about 287 feet, the well casing  
13 is extensively corroded away, with approximately 1/3 of the casing completely gone.  
14 An 8-inch diameter PVC well liner and gravel pack envelope were reportedly installed

*Side view of Well No. 5 at 212 feet\* below land surface, showing large corrosion hole in the well casing.*

15 in Well No. 5 to address the instability and sand invasion issues that resulted from the  
16 multiple corrosion holes in the casing. Ray Water Company records indicate that after  
17 installation of the liner, the well was then equipped with a 75 gpm pump, but the well  
18 could not sustain that pumping rate without breaking suction at the pump intake  
19 (which results from excessive water-level declines). Well No. 5 has not been in use  
20 since 2005. Due to the age (46 years old) and extensive corrosion of Well No. 5,  
21 along with the history of other wells in the Ray Water Company service area, Well  
22 No. 5 is considered to have reached the end of its economically useful life.  
23

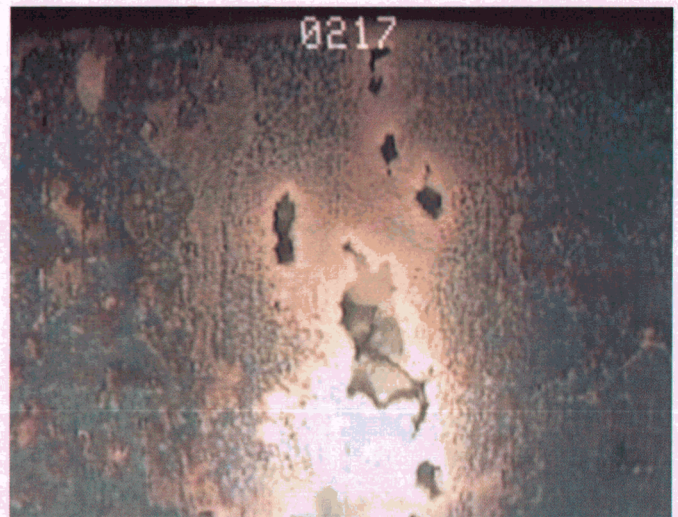
*Side view of Well No. 5 at 215 feet\* below land surface, showing multiple corrosion holes in the well casing.*

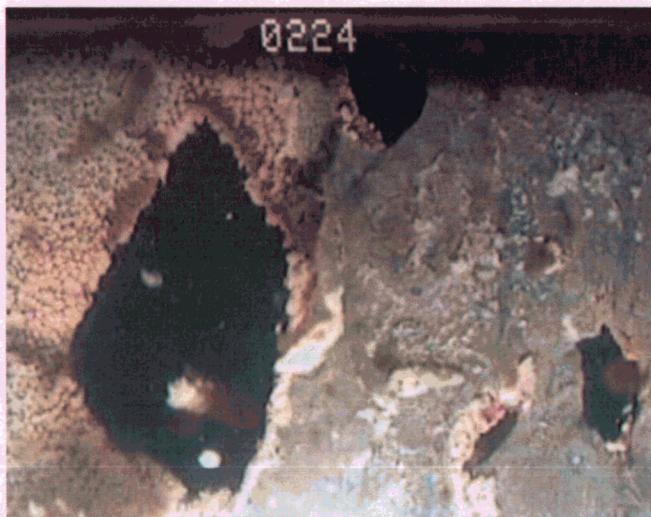
*Side view of Well No. 5 at 222 feet\* below land surface, showing multiple corrosion holes in the well casing.*

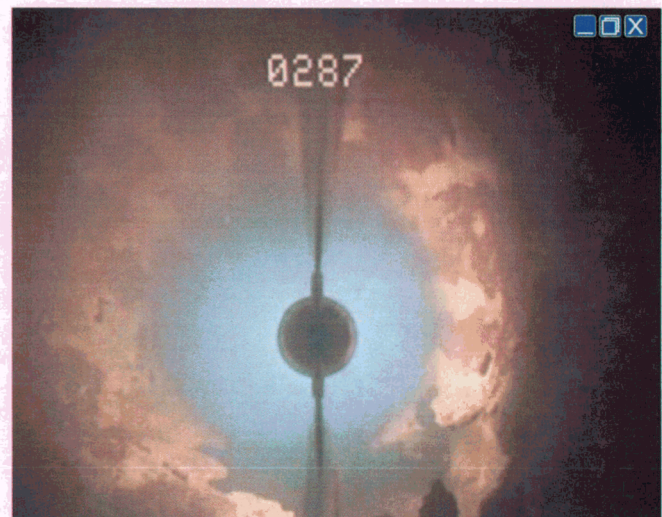
*Downward view of Well No. 5 at 287 feet\* below land surface, showing extensive corrosion, with about 1/3 of well casing completely gone.*

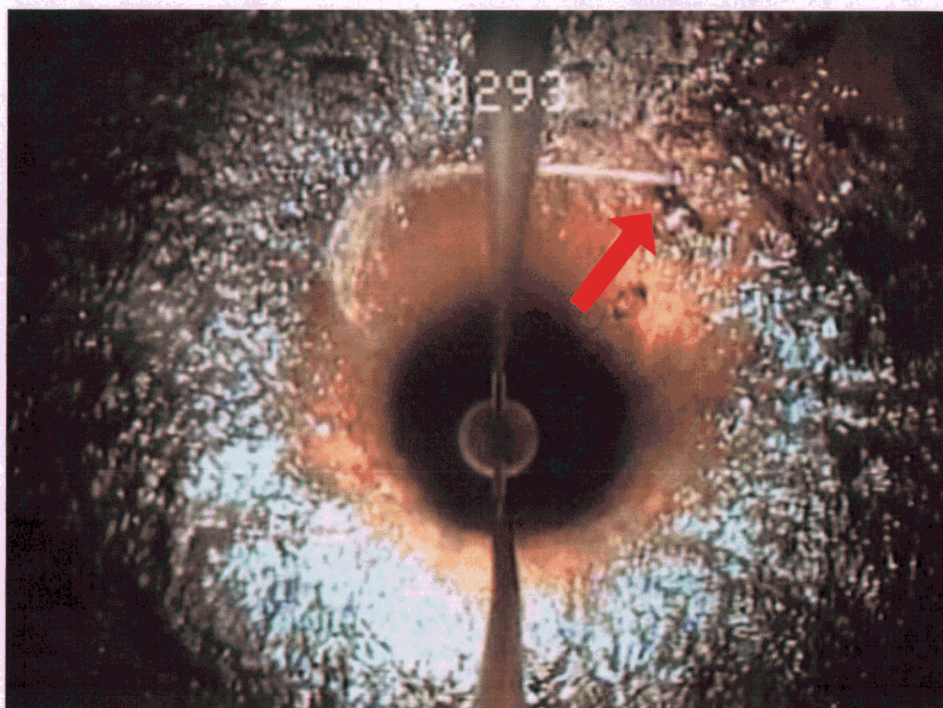
The details of the failed well are as follows: On or about December 6, 2008, Ray Water Well #6 stopped operating. After the pump and submersible motor were pulled and the well was videoed, it was determined that there were many holes in both the well's blank casing and screen. Because of the poor condition of the casing and screen, our hydrology consultants, Clear Creek Associates, recommended abandoning the existing well and drilling a replacement well.

13 (average decline of 6.5 feet per year). Review of the December 1, 2008 video for this  
14 well indicates that the well has a split casing at a depth of about 293 feet, which is  
15 allowing cascading water to enter the well (Attachment A). Cascading water such as  
16 this is commonly of poor quality, and may lead to pump damage and accelerated scale  
17 growth and corrosion of the well casing. The December 2008 video of Well No. 6  
18 also indicates multiple locations with corrosion holes and casing splits (Attachment  
19 A). In the screened interval of Well No. 6, the wire-wrapped screen was observed to  
20 be ripped at a depth of about 541 feet, with filter pack and native sediment spilling in  
21 through the ripped area (Attachment A). Due to its age (26 years old), extensive  
22 corrosion, and damaged screen, Well No. 6 is considered to have reached the end of its  
23 economically useful life.

*Downward view of Well No. 6 at 293 feet\* below land surface, showing cascading water (see arrow) entering the well through a hole in the split casing.*

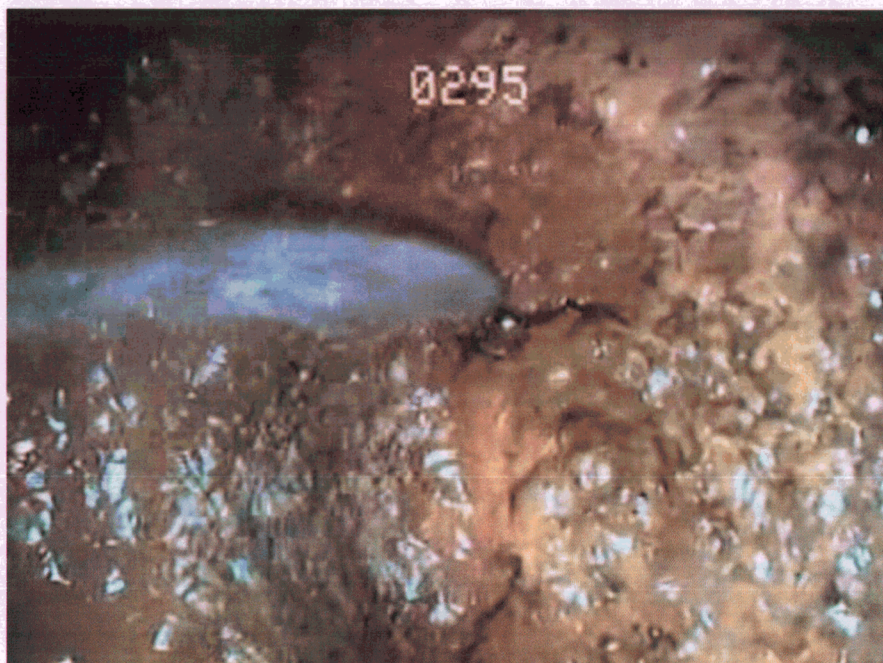
*Side view of Well No. 6 at 293 feet\* below land surface, showing a close up view of cascading water entering the well.*

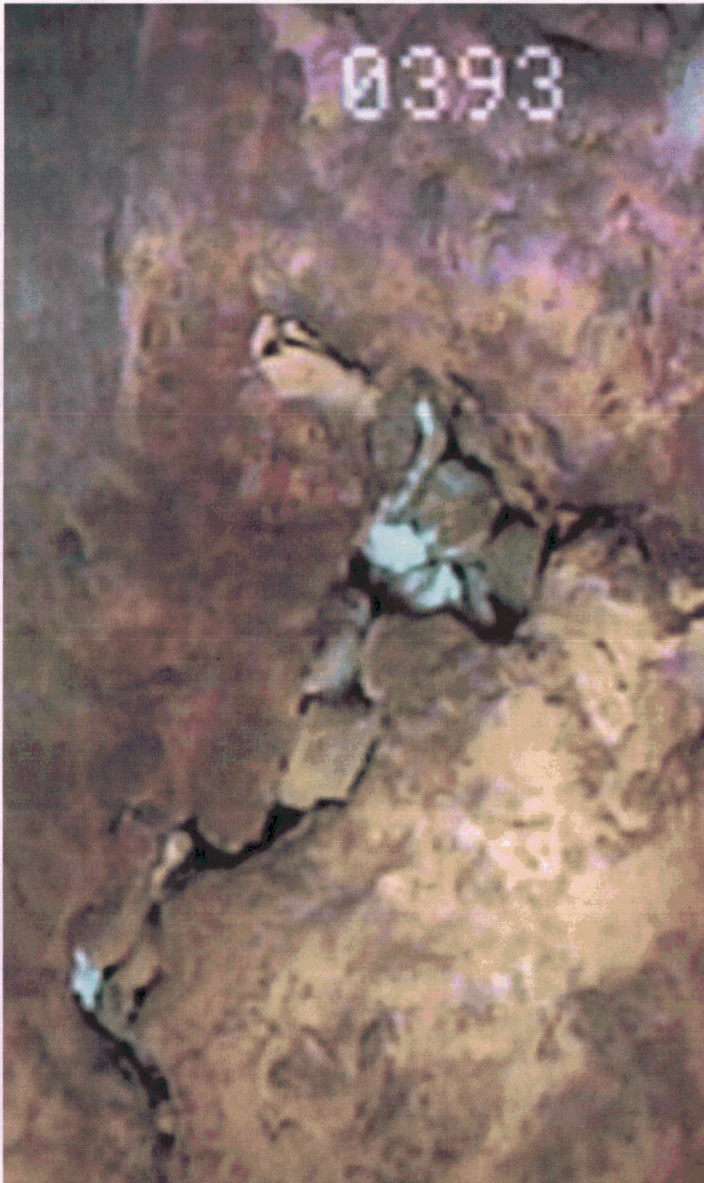
*Side view of Well No. 6 at 391 feet\* below land surface, showing close up view of split well casing and gravel pack coming through.*

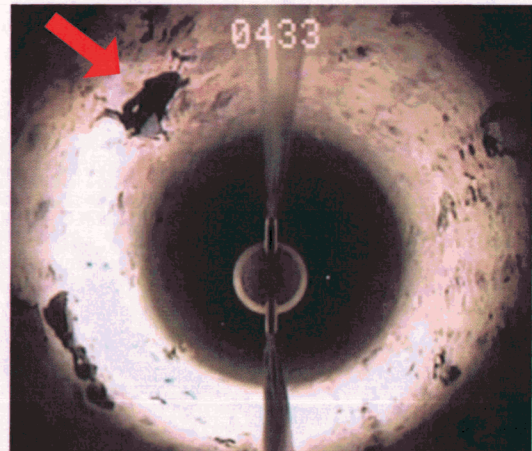
*Downward view of Well No. 6 at 433 feet\* below land surface, showing corrosion hole in well casing (see arrow).*

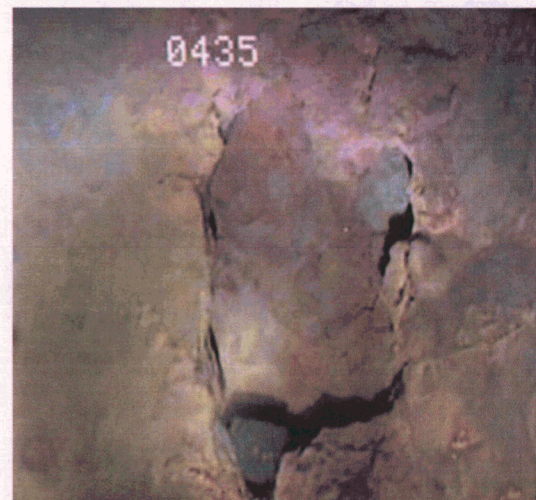
*Side view of Well No. 6 at 433 feet\* below land surface, showing detail view of corrosion hole in well casing.*

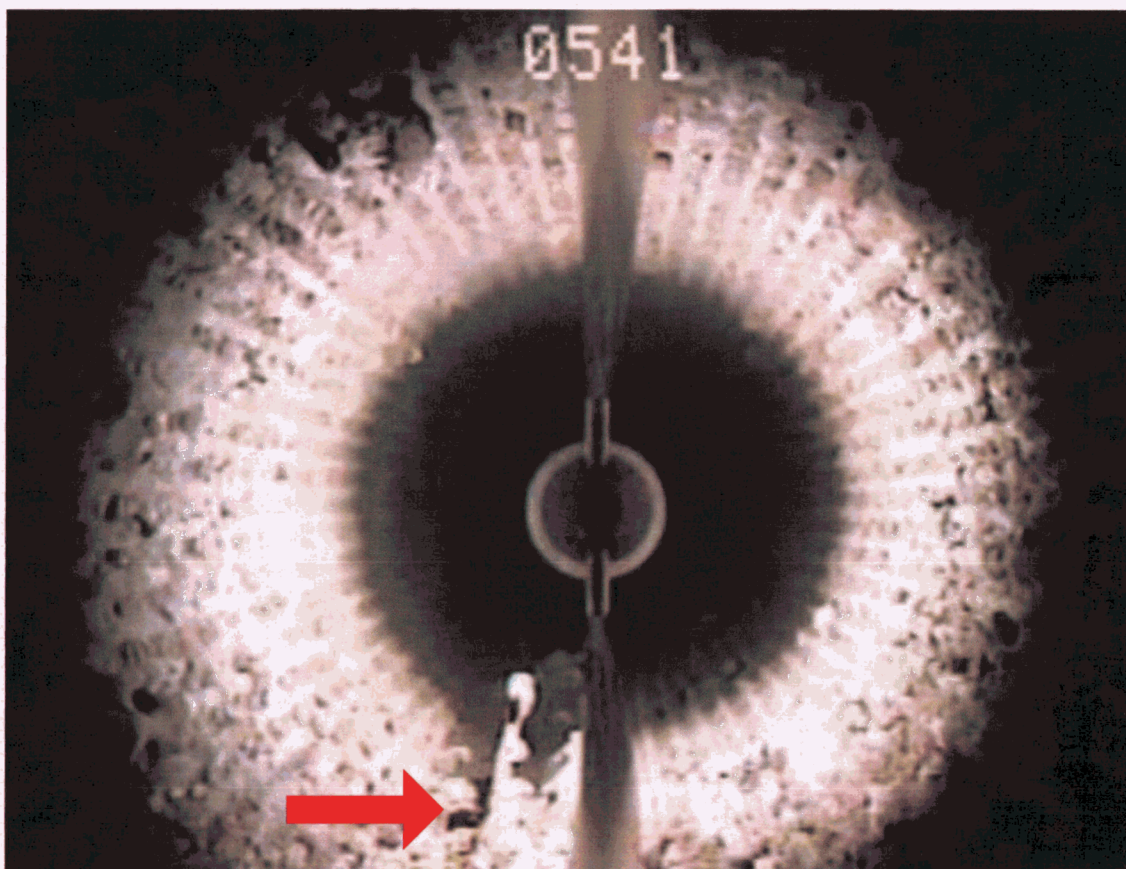
***Downward view of Well No. 6 at 541 feet\* below land surface, showing ripped wire-wrap well screen (see arrow).***

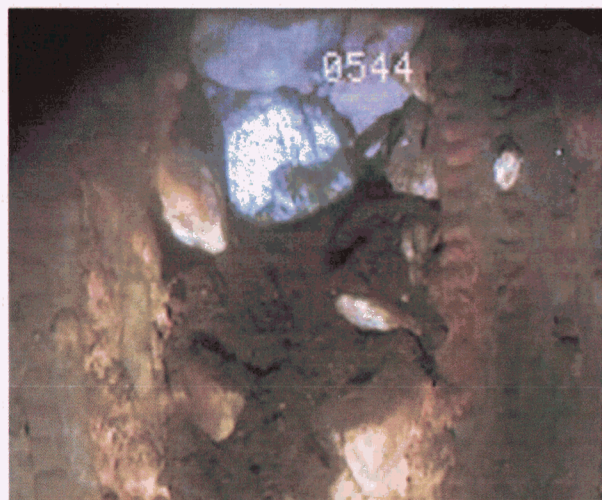
***Side view of Well No. 6 at 542 feet\* below land surface, showing close up view of ripped well screen with gravel pack coming through.***

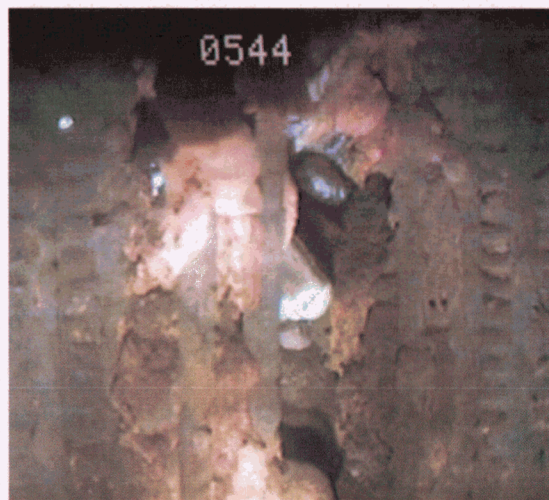
***Side view of Well No. 6 at 542 feet\* below land surface, showing close up view of ripped well screen with gravel pack coming through.***
